Manhole Inspection Summary

Manhole # S43I2_012MH

Location Address: **1233 Church St.**

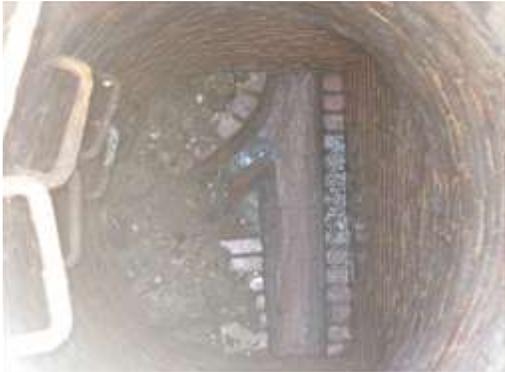
Top View

Condition: Sound Cracked Root Intrusion Loose Brick **Deteriorated**

Infiltration: None **Joint** **Cracks** Mortar Roots Wall
